Fw: Fwd: 2726 W. Cortez

Water Leak Investigation Results:

2726 West Cortez Condominium Association

Leak Inspection Report.

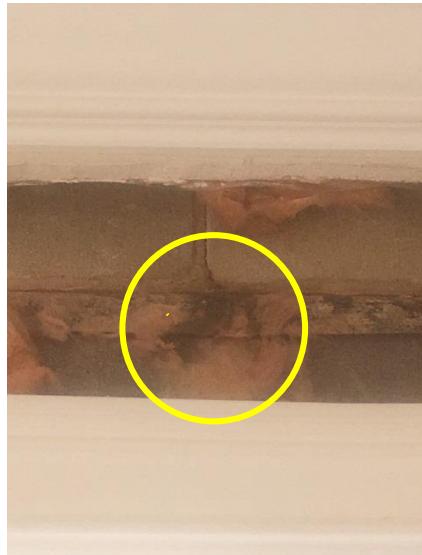
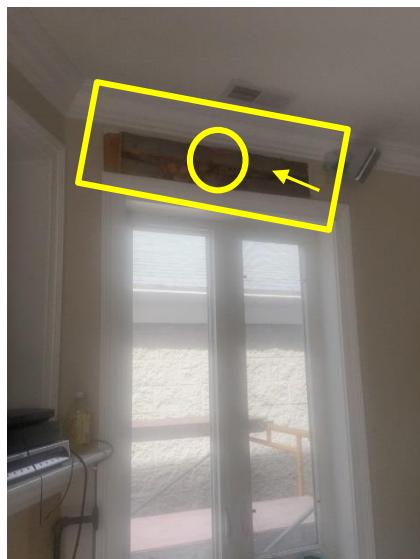
The removal of drywall allowed BRAL to confirm there is not a cavity wall system to be repaired and or reviewed. The existing flashing was through wall that allowed water to penetrate right into the back of block.

**Location of Interior Water Leak
3rd Floor Window Head.**

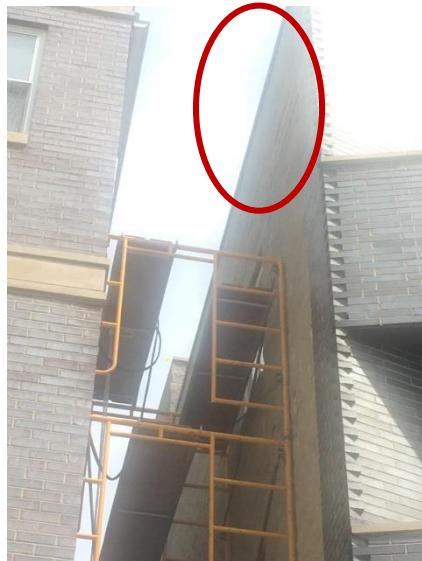
3rd Floor Leak Location Testing.

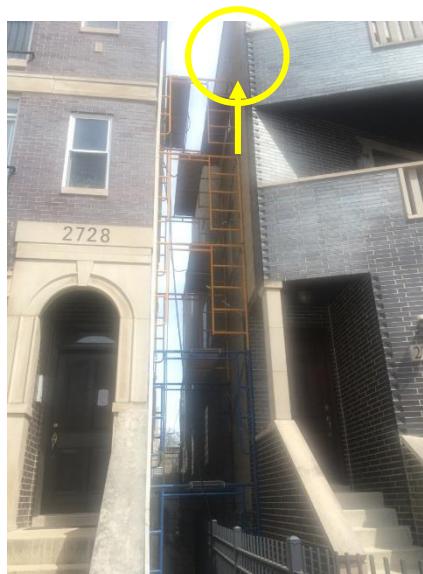
3rd Floor Leak Location.

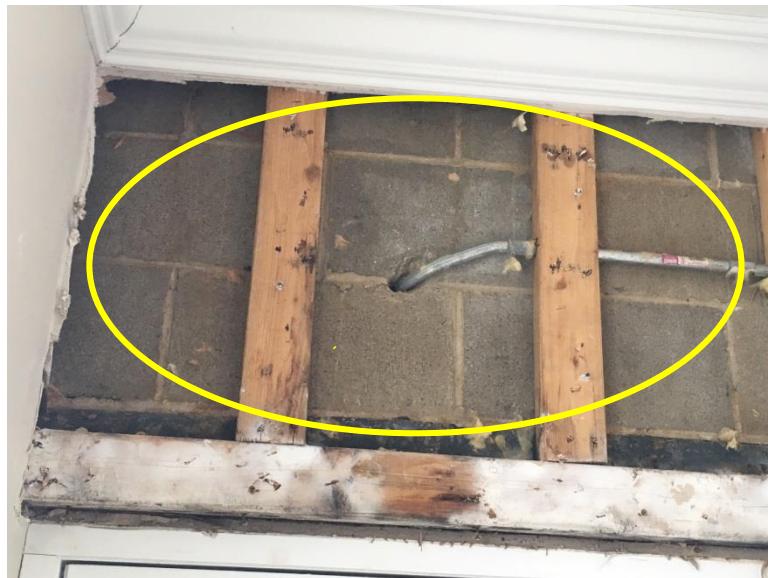
We completed similar protection and opening above the North door of 3rd floor.

North Door Leak Testing.

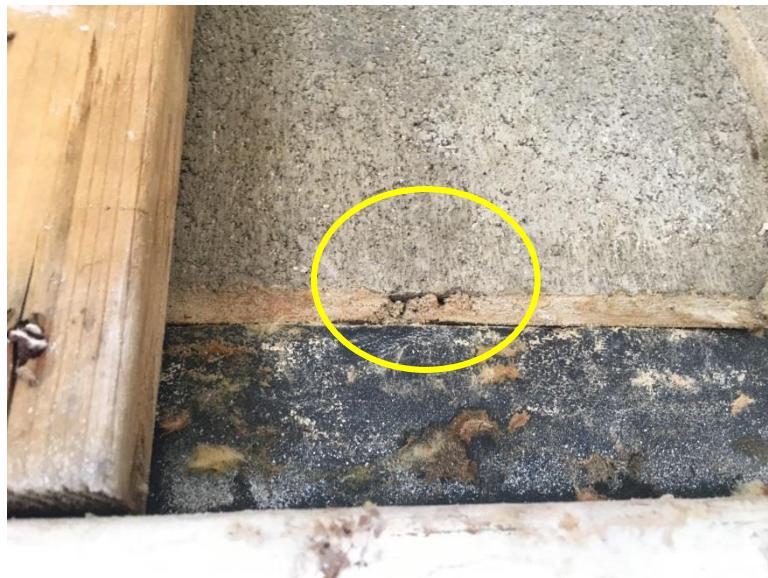
Leak Location North Door.
